U.S. EPA REGION VIII
TECHNICAL ENFORCEMENT PROGRAM
RCRA CORRECTIVE ACTION ASSESSMENT REPORT

Facility: ASARCO East Helena Plant
100 Smelter Road
East Helena, MT

Inspection Type: Corrective Action Assessment Inspection

Date: May 8, 2007

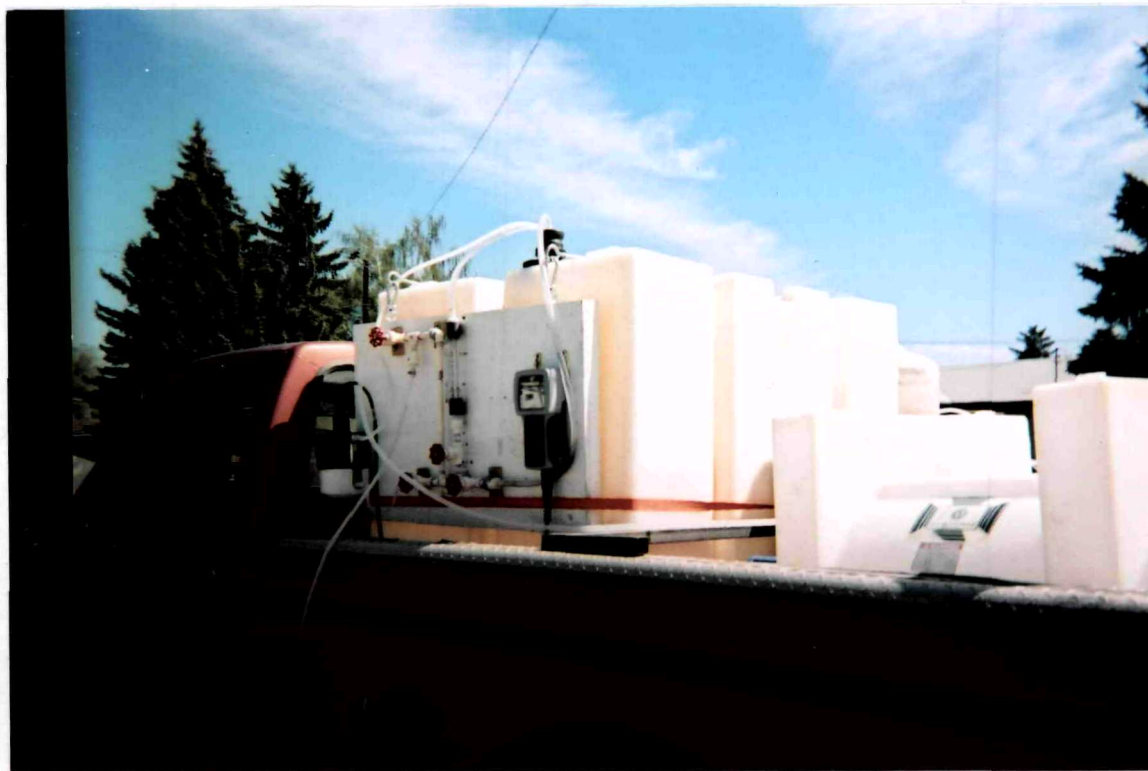
Photo 6; Facility: ASARCO East Helena Smelter; Subject: Truck-Mounted Sampling Unit; Photographer: Linda Jacobson; Date: May 11, 2007

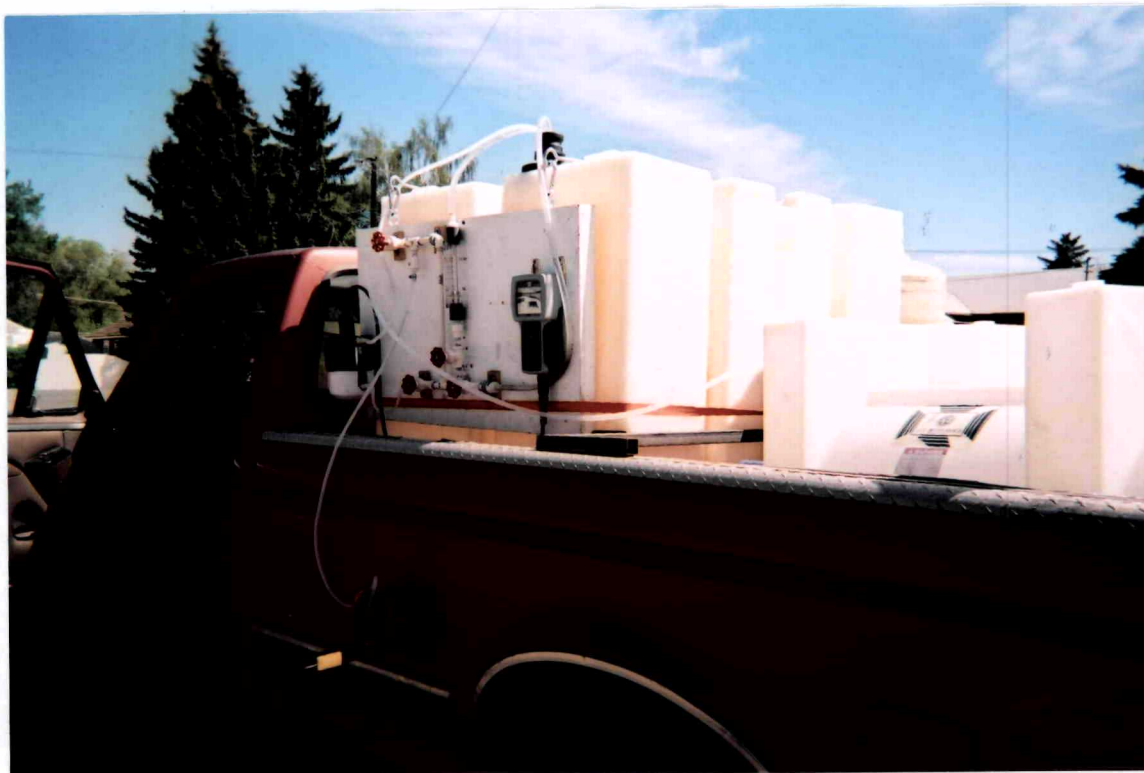
Photo 7; Facility: ASARCO East Helena Smelter; Subject: Truck-Mounted Sampling Unit; Photographer: Linda Jacobson; Date: May 11, 2007

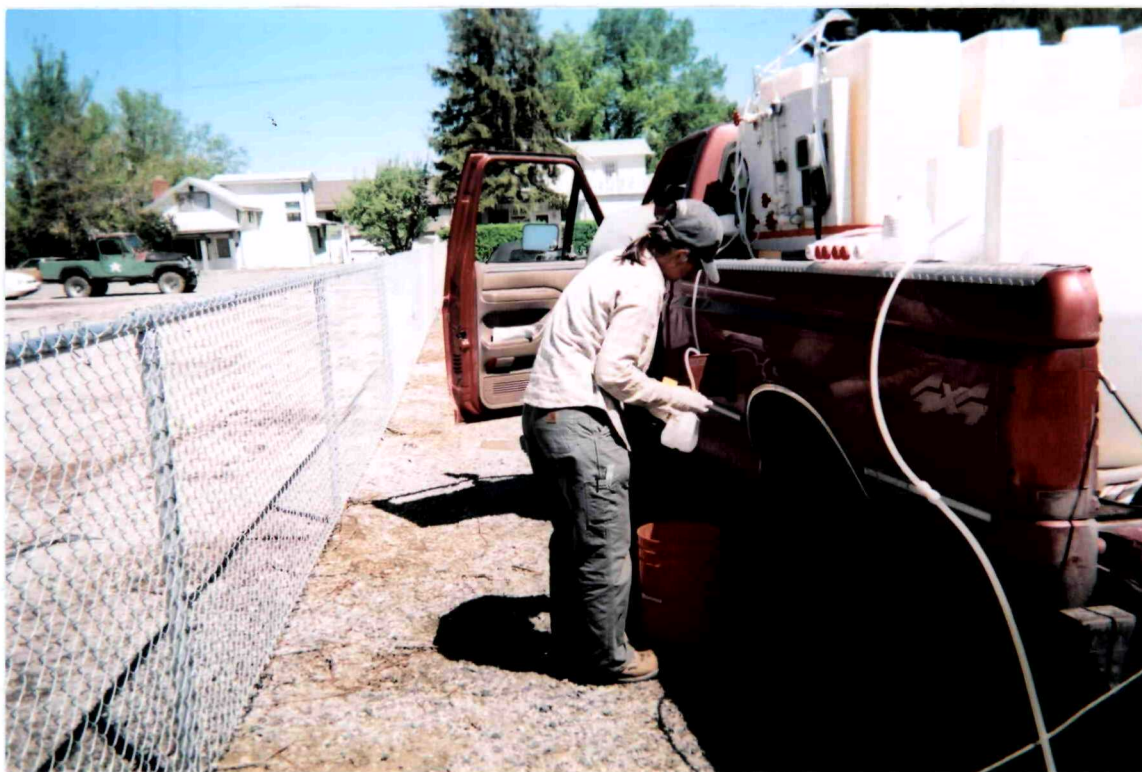
Well EH-102 is a flush mounted well with a screw cap and internal locking lid. The total depth measured was 35 feet, with a static water level of 9 feet. Ms. Jacobson observed the collection of the sample for common ions, followed by collection of the other well samples after the field filter was attached. Three casing volumes were purged from the well. It was noted that the sample container was rinsed three times with sample water before collection. Samples were stored in a cooler, following collection. Upon completion of sampling, the well was relocked and the outside lid replaced.

Photo 10; Facility: ASARCO East Helena Smelter; Subject: Collection of Common Ions Sample; Photographer: Linda Jacobson; Date: May 11, 2007

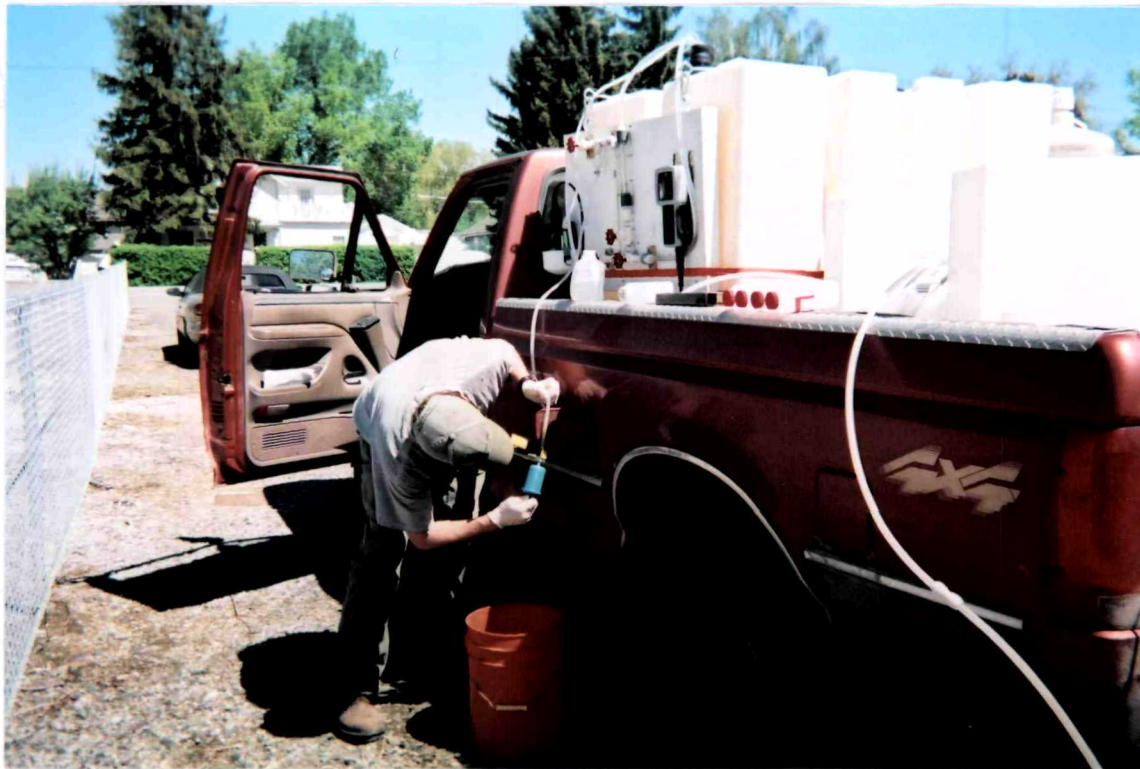
Photo 11; Facility: ASARCO East Helena Smelter; Subject: Attaching Field Filter; Photographer: Linda Jacobson; Date: May 11, 2007

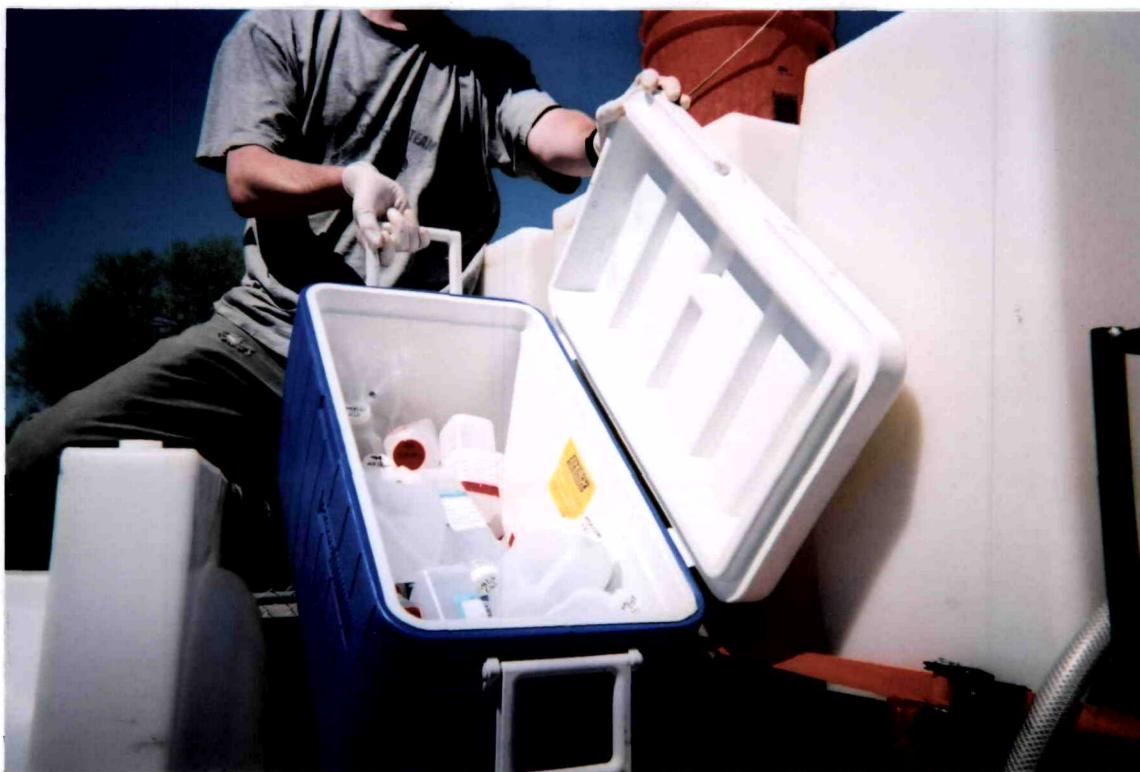
Photo 12; Facility: ASARCO East Helena Smelter; Subject: Storage of Labeled Collected Samples in Cooler; Photographer: Linda Jacobson; Date: May 11, 2007

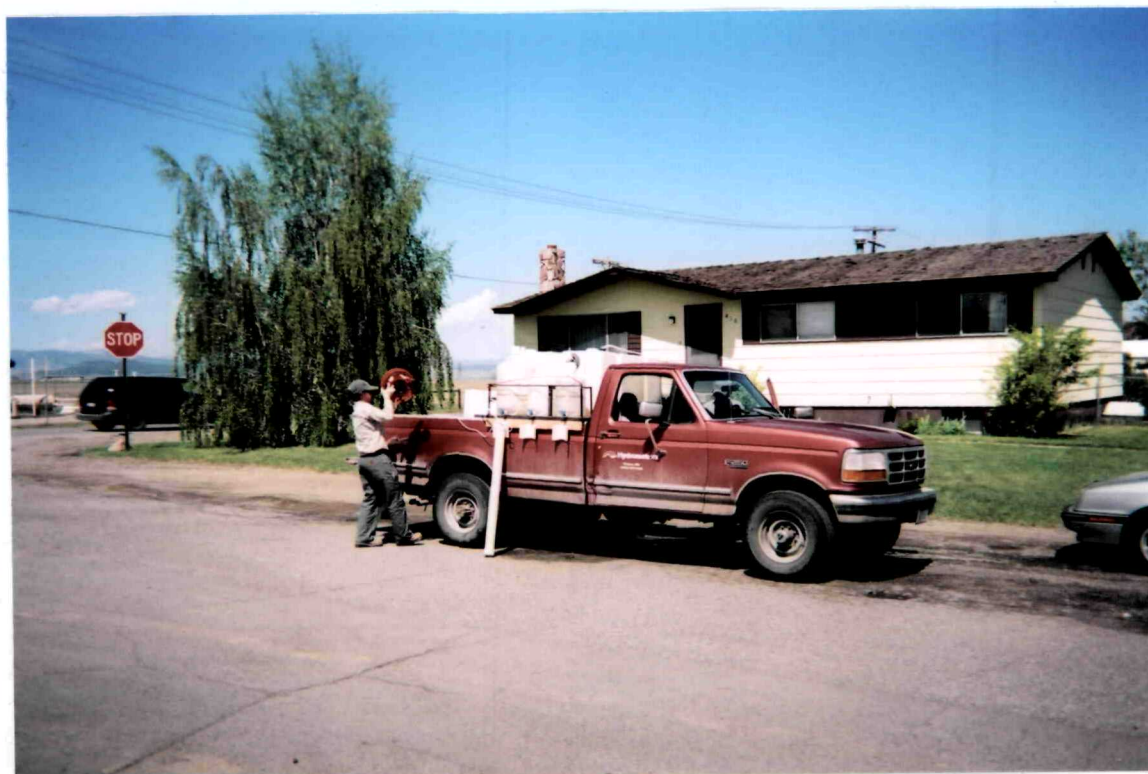
Photo 16; Facility: ASARCO East Helena Smelter; Subject: Preparing to Sample EH-115 on Riggs; Photographer: Linda Jacobson; Date: May 11, 2007

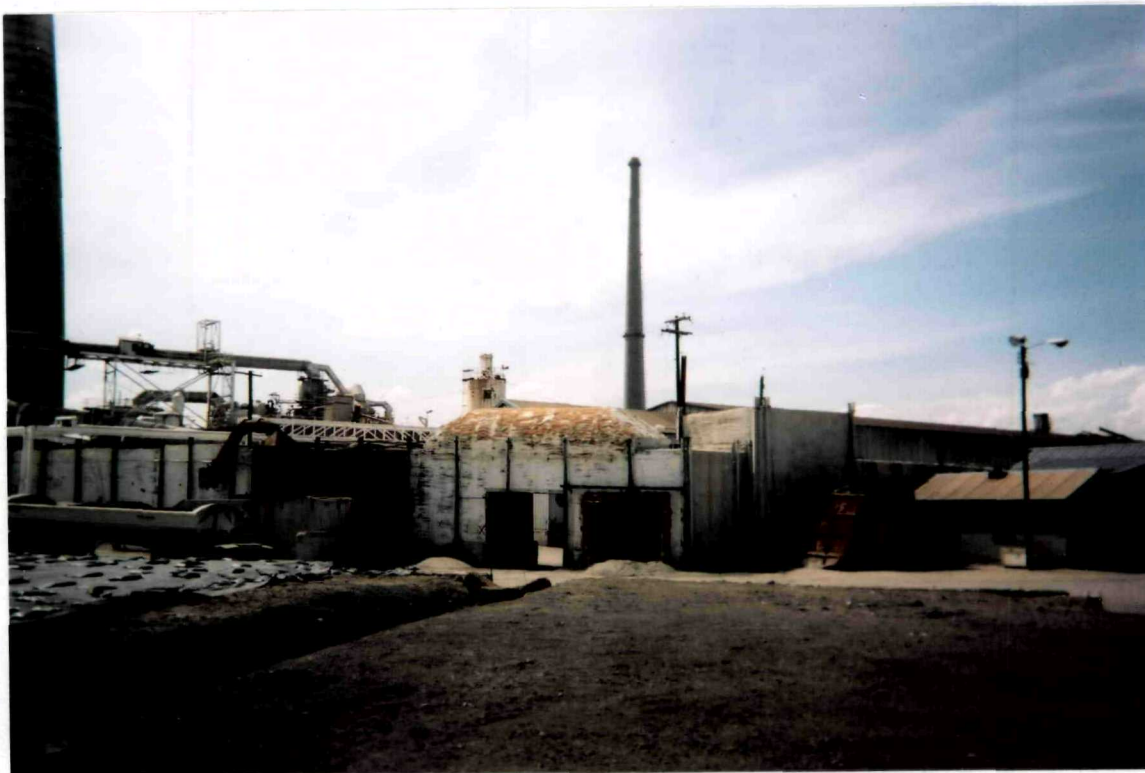
Photo 17; Facility: ASARCO East Helena Smelter; Subject: Flue Structure Adjacent to Former APSD; Photographer: Linda Jacobson; Date: May 11, 2007

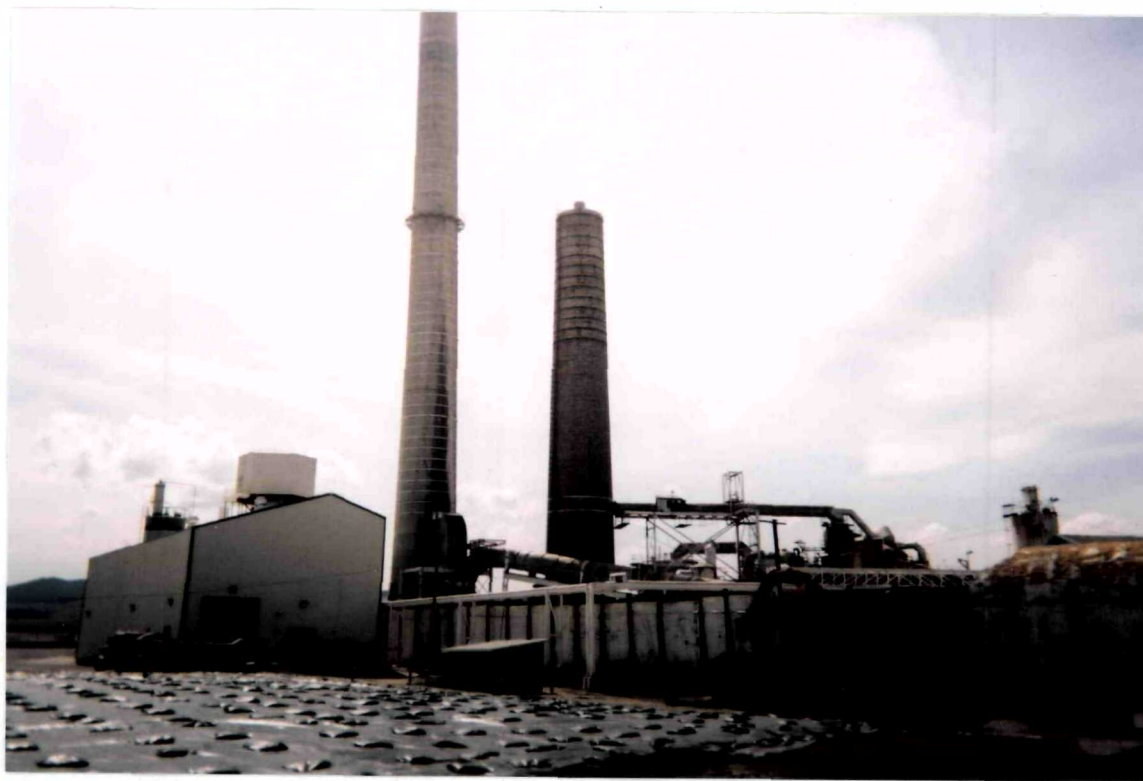
Photo 18: Facility: ASARCO East Helena Smelter; Subject: Former APSD in Foreground, Flue Structure, Stacks in Background; Photographer: Linda Jacobson; Date: May 11, 2007

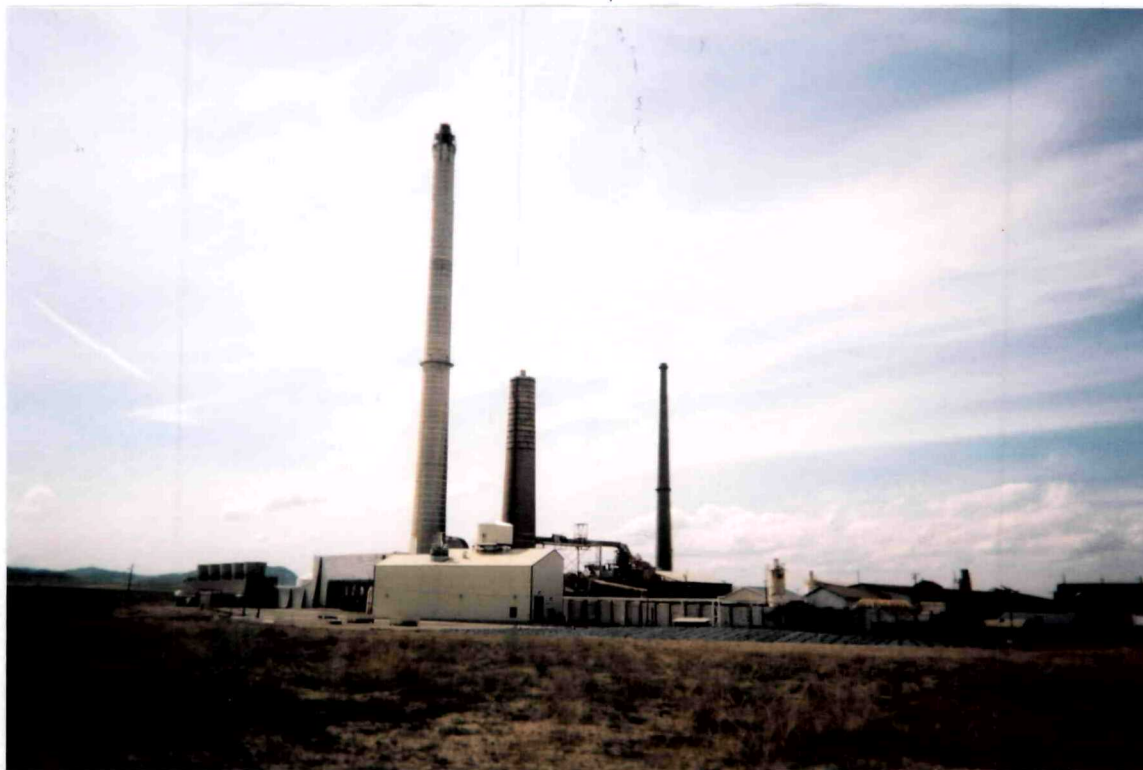
Photo 19; Facility: ASARCO East Helena Smelter; Subject: 3 Stacks and a Flue ; Photographer: Linda Jacobson; Date: May 11, 2007

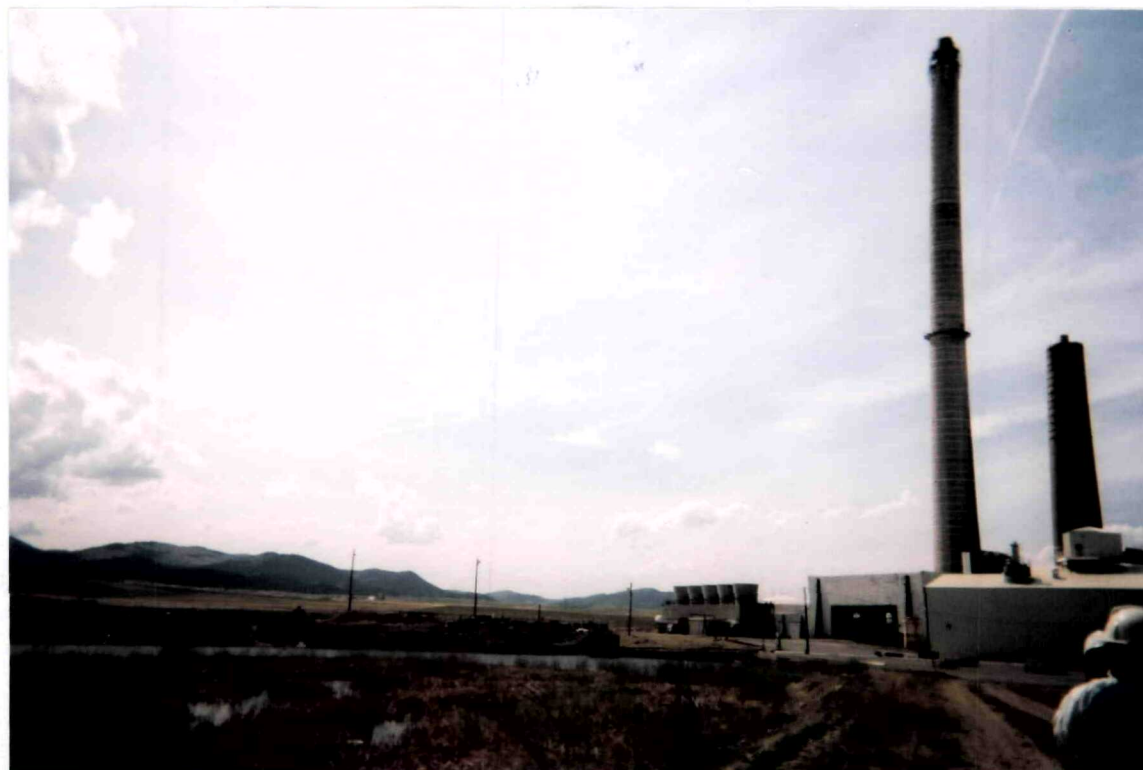
Photo 20; Facility: ASARCO East Helena Smelter; Subject: Upper Lake to Left, Remaining Structures to Right; Photographer: Linda Jacobson; Date: May 11, 2007

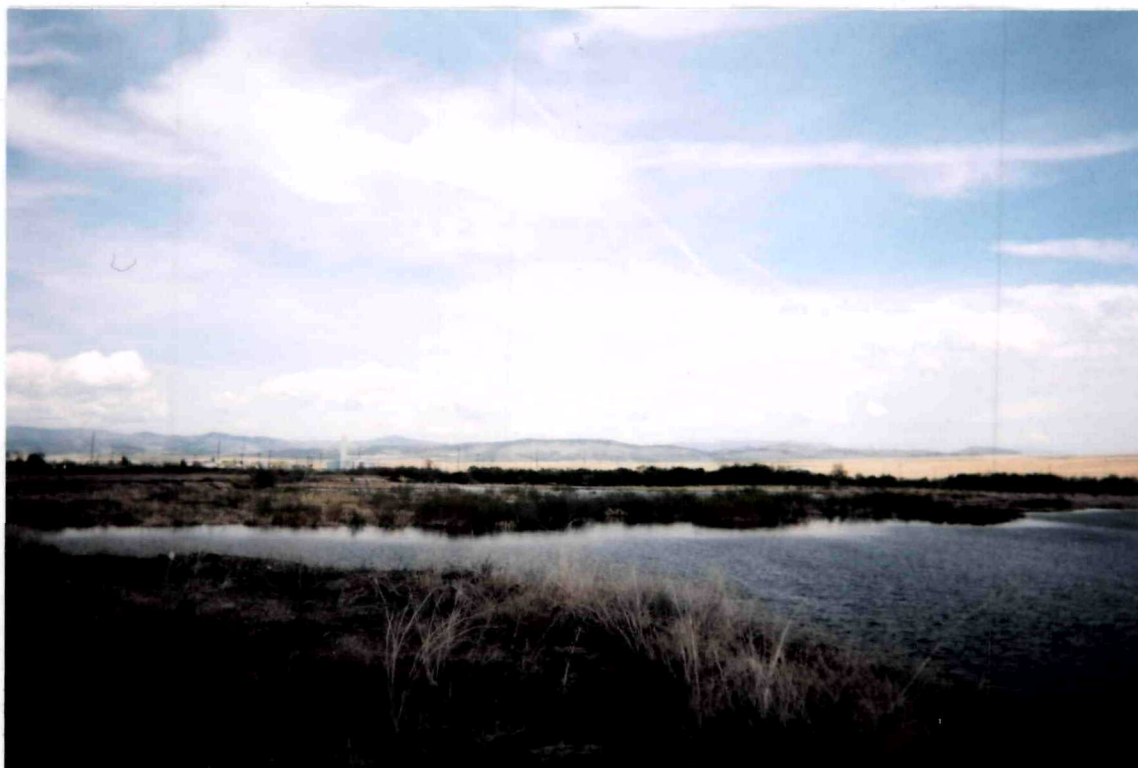
Photo 21; Facility: ASARCO East Helena Smelter; Subject: ASARCO Lake; Photographer: Linda Jacobson; Date: May 11, 2007

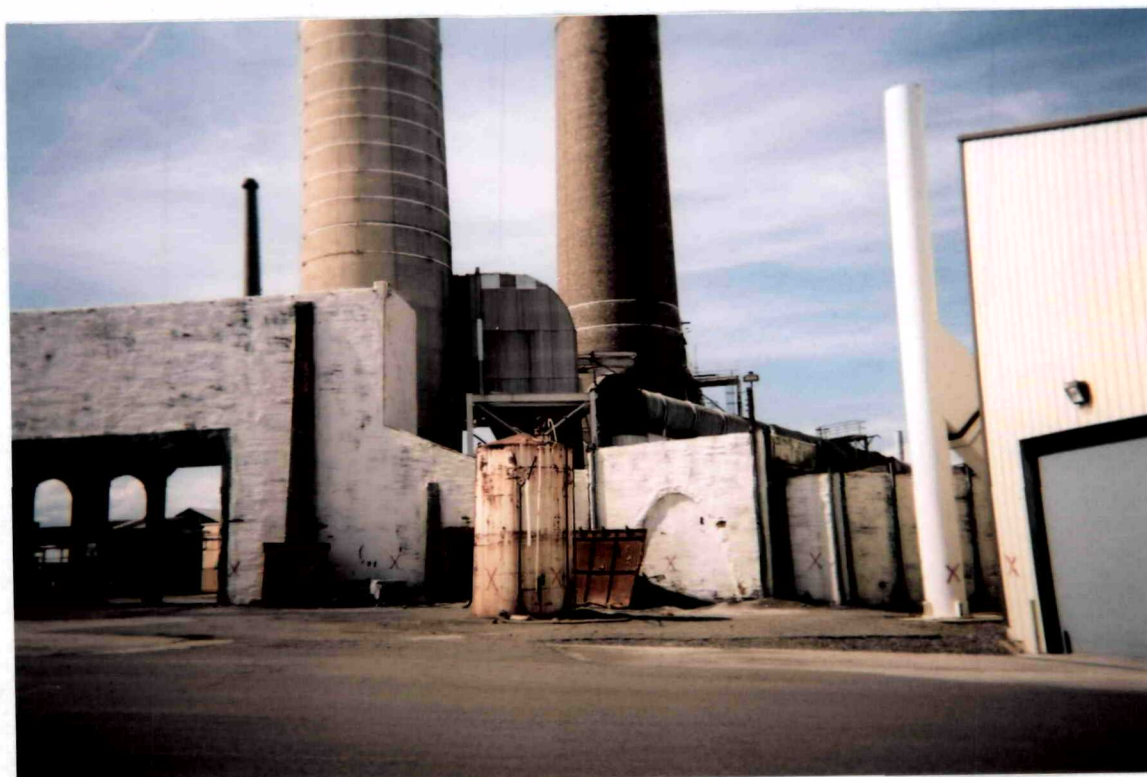
Photo 22; Facility: ASARCO East Helena Smelter; Subject: Flue Structures to be Demo'd in 2007; Photographer: Linda Jacobson; Date: May 11, 2007

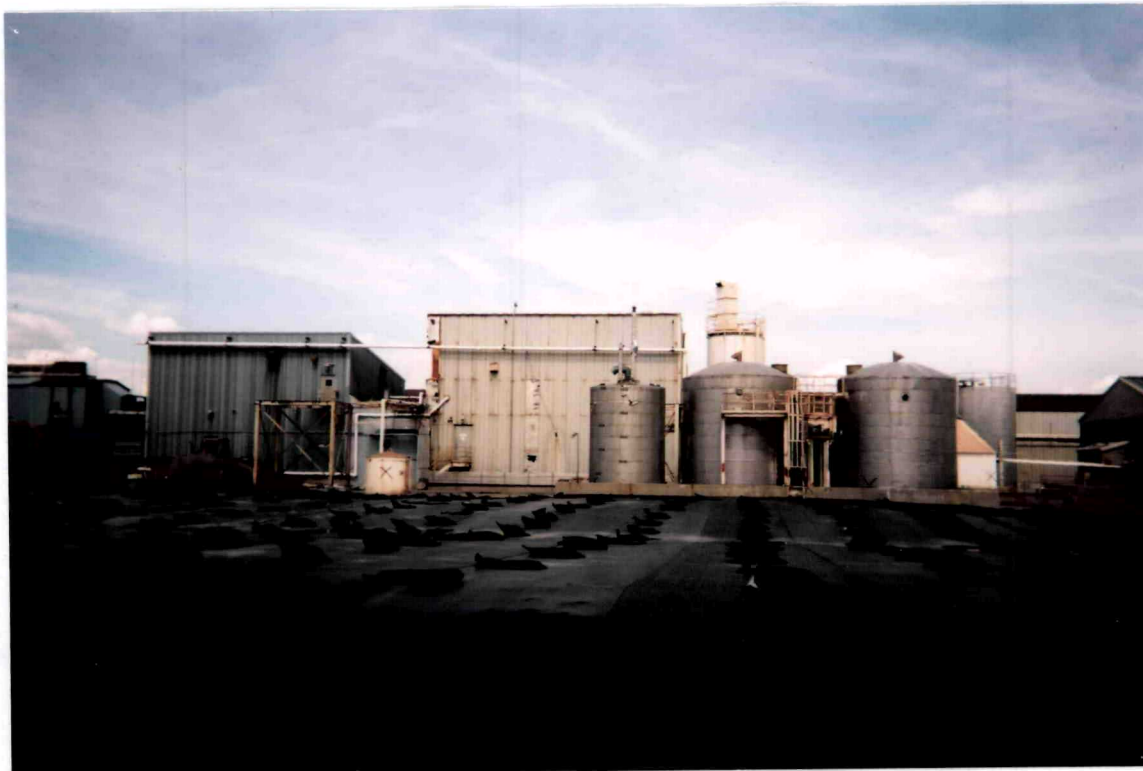
Photo 25; Facility: ASARCO East Helena Smelter; Subject: Winter Storage Tanks, Wastewater Treatment Building, Temporary Cap; Photographer: Linda Jacobson; Date: May 11, 2007

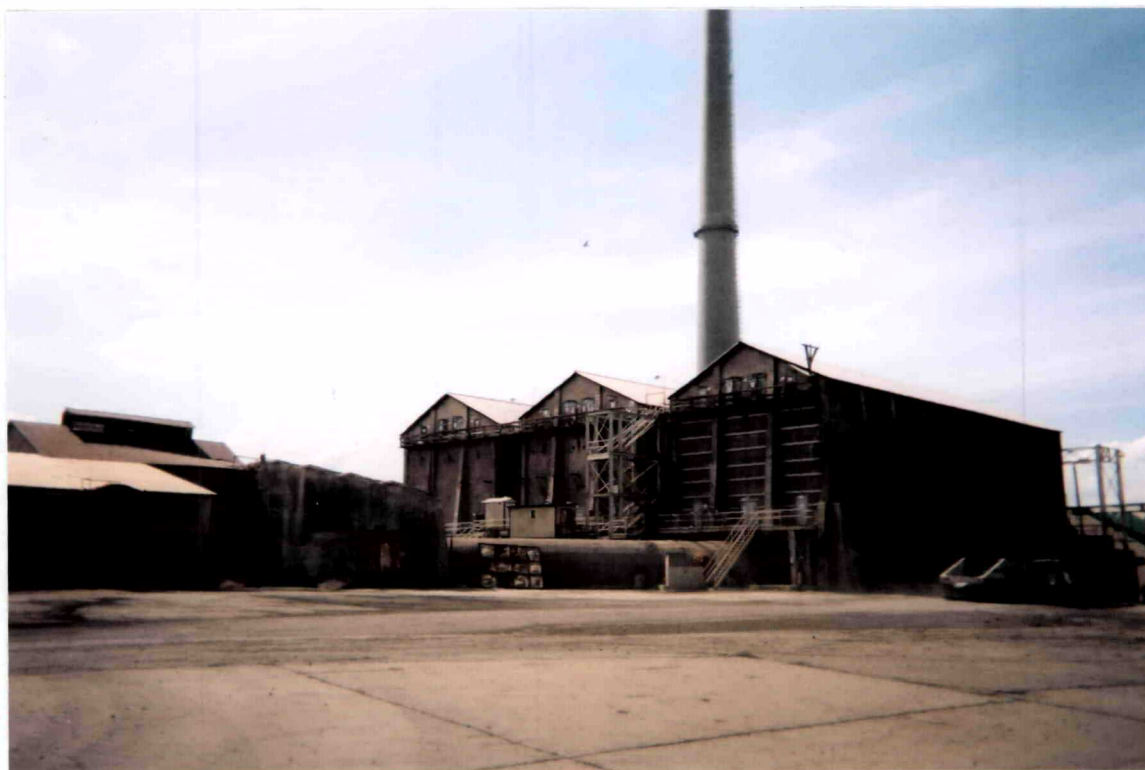
Photo 26; Facility: ASARCO East Helena Smelter; Subject: Bag Houses and Stack; Photographer: Linda Jacobson; Date: May 11, 2007
